Manhole Inspection Summary

Manhole # S43I__050MH

Location Address: **1522 Eastern av**

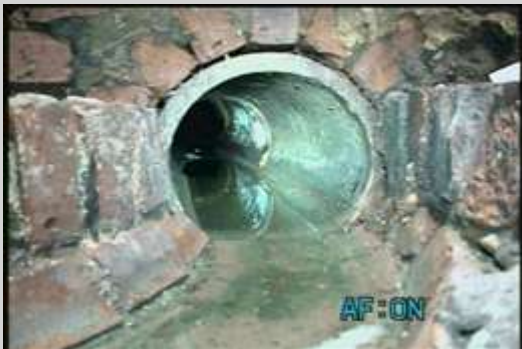
3 O'Clock Inflow

Pipe Height: 0 (in.) Direct

Pipe Material: **Clay** ☐ Pipe Lined

Invert Depth: **8.16** (ft.) Flow Characteristics: **Slow**

Deposits: ☒ None ☐ Mud ☐ Sludge ☐ Debris ☐ Grease

Infiltration: **None** Pipe Seal Cond: **Unknown**

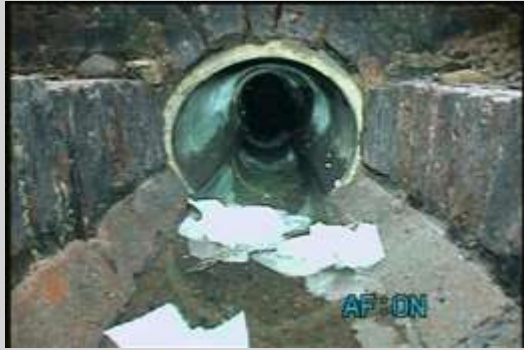
6 O'Clock Inflow

Pipe Height: **0** (in.) Direct

Pipe Material: **Clay** ☐ Pipe Lined

Infiltration: **None** Pipe Seal Cond: **Unknown**
